**PHOTO LOG FOR GARY DEVELOPMENT LANDFILL, GARY, INDIANA
IND 077 005 916**

DEPARTMENT OF
ENVIRONMENTAL MANAGEMENT
OFFICE OF LAND QUALITY

Inspection conducted September 26, 1996

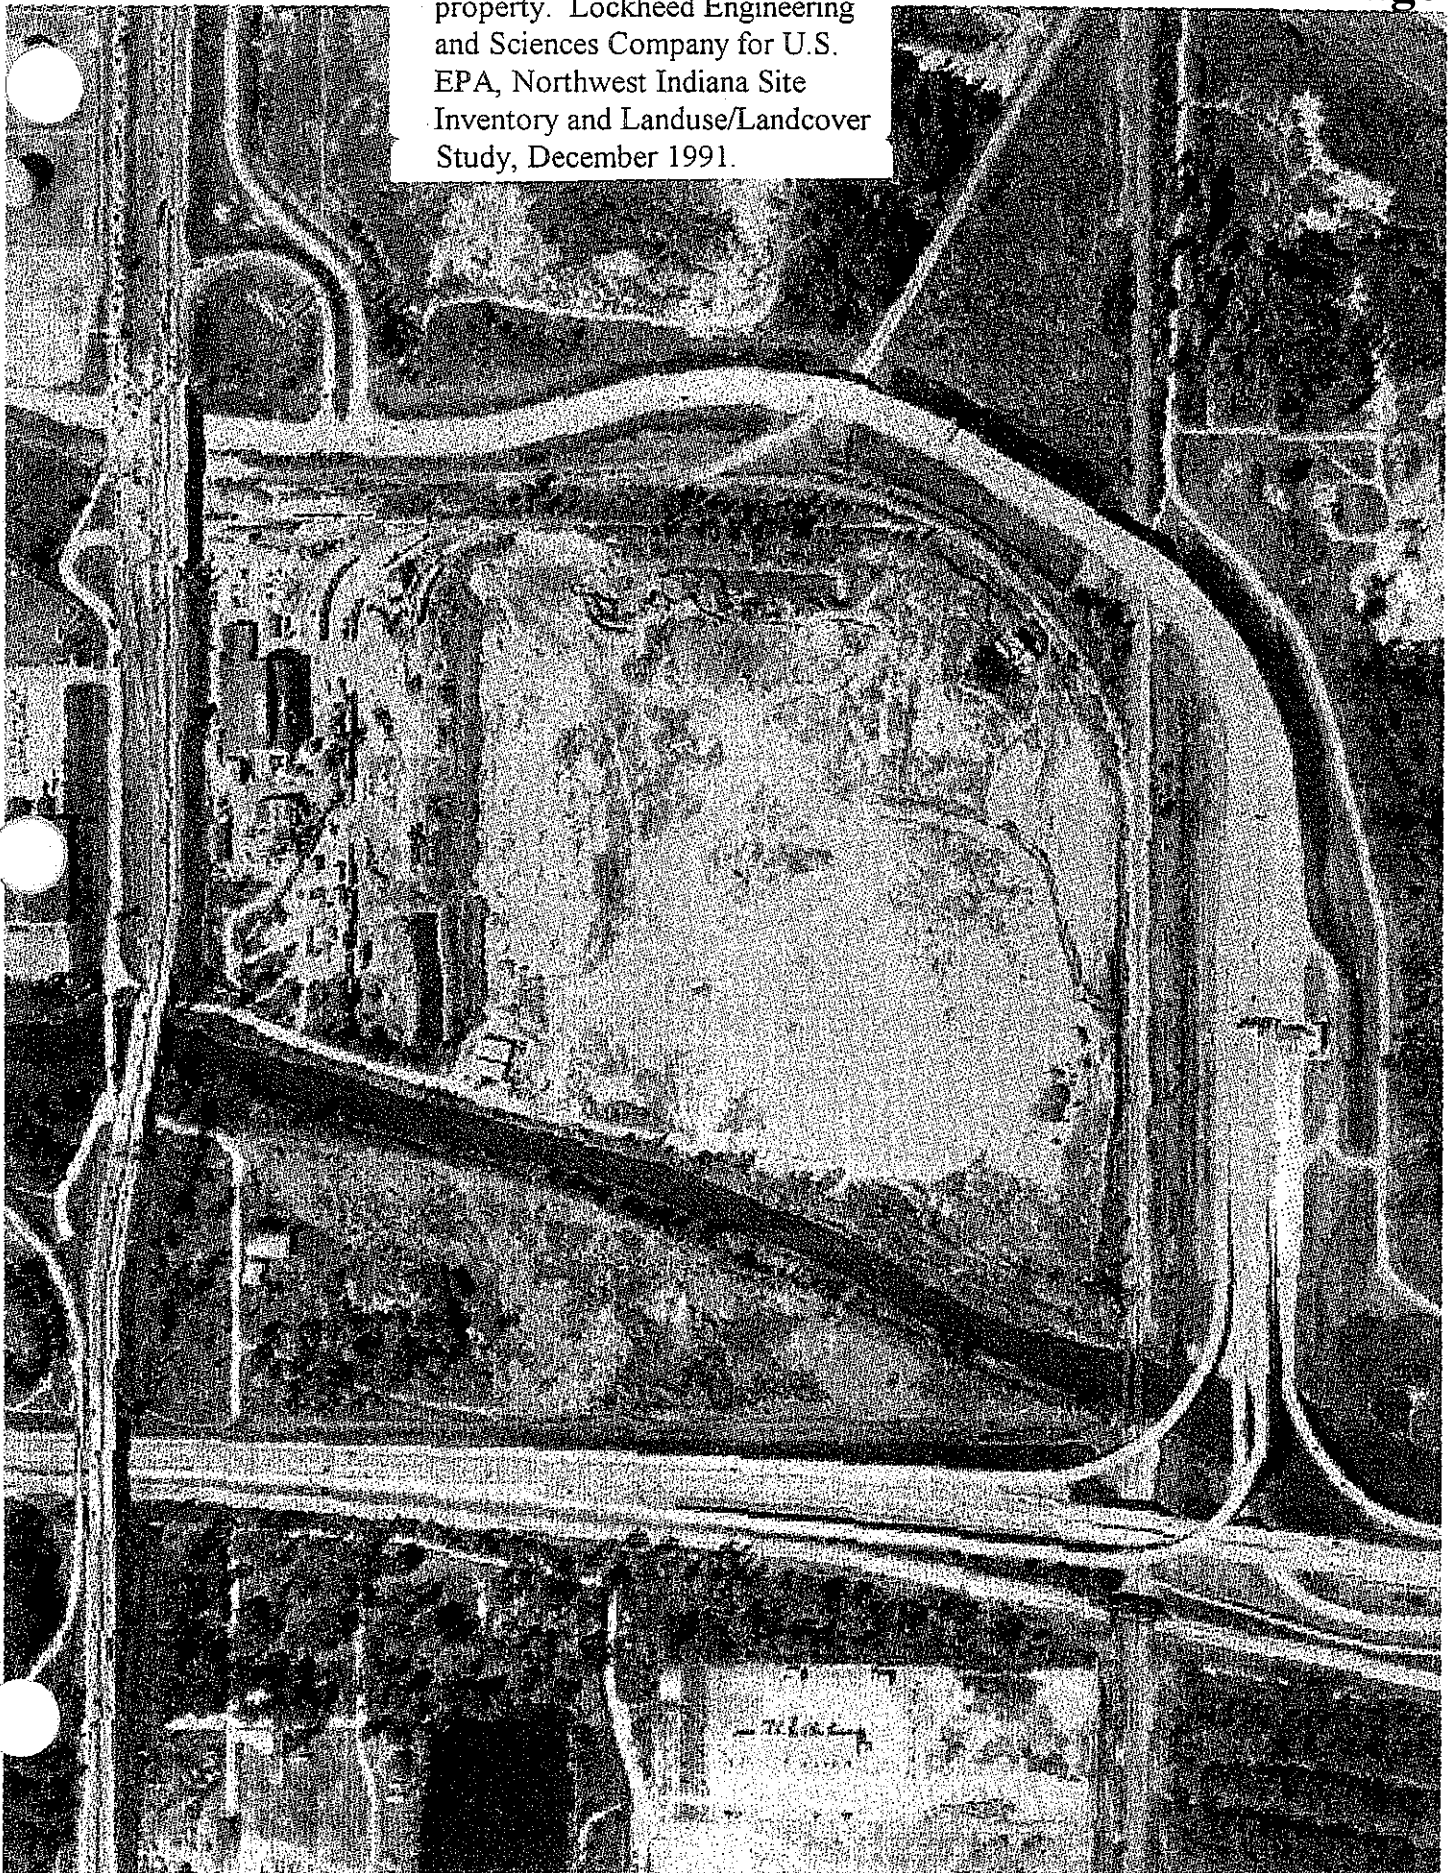
9-25-90 Air photo of GDC property. Lockheed Engineering and Sciences Company for U.S. EPA, Northwest Indiana Site Inventory and Landuse/Landcover Study, December 1991.
